**Flood Control Project Maintenance  
Levee Inspections**  
**LMA District Cover Sheet**  
**Spring 2017 Levee Inspection Results**

**Levee District No. 0001 (Sutter County)**

**Spring 2017 Levee Inspection Results**

Waterway			Bank	Unit Miles
Unit No. 01 Feather River			Right	16.11
	Spring (March - May)	Summer (June - August)	(September - November) Fall	Winter (December - February)
Unit Maintenance Rating (Fall Only)				
Date of Inspection	4/4/2017 - 4/4/2017			
DWR Inspector	Sterling York			
Accompanied By	Andrew Stresser LD0001S

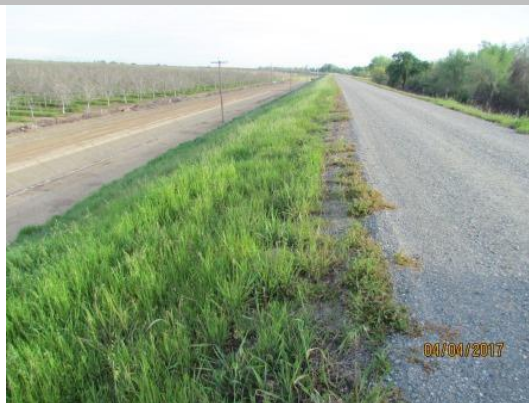
Photo 1 of 1 : SP\_2017\_LD0001S\_433\_30\_20170404\_00061.jpg

View of annual grasses that need to be maintained. Spring 2017.

LM Start	0.01	Rating **	M	Issue No.	31
LM End	16.09	Issue Type +	Ma	Location *	WS
Category	Earthen Levee			GPS Latitude/Longitude	
				Start	End
Item	Vegetation			38.951109 °	39.168577 °
				-121.585711 °	-121.622691 °
DWR ID	DWR_LD0001S_01_f _ 2016_31				
Comment Code					
V1 : Control annual grass and weeds on the levee slopes and easements.					
Inspector Comment					
Annual grasses need to be maintained. Spring 2017.

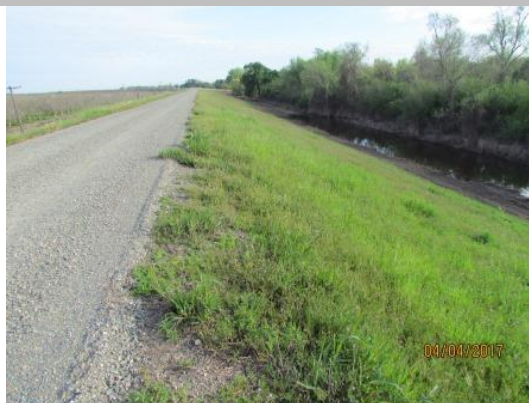
Photo 1 of 1 : SP\_2017\_LD0001S\_433\_31\_20170404\_00060.jpg

View of annual grasses that need to be maintained. Fall 2016.

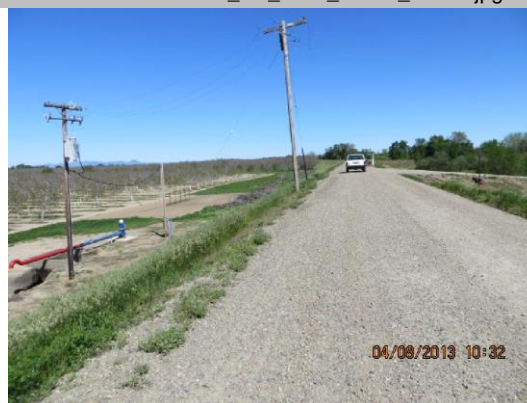
Photo 1 of 3 : UCIP\_SP\_2017\_41624\_18769.jpg

LM Start	0.36	Rating **	M	Issue No.	490
LM End	0.36	Issue Type +	En	Location *	WS
Category	Supplemental			GPS Latitude/Longitude	
				Start	End
Item	DWR UCIP Field Study			38.956192 °	38.956192 °
				-121.585510 °	-121.585510 °
DWR ID					
Comment Code					
Inspector Comment					
FS_ID:41624 DS_ID:18653 EP_NO: 4667 Repair Type: Non-Urgent Crossing Status: Found UCIP Comments: Abandoned crossing. Concrete box on both sides found. Pipe remainings are found on WS. FIELD_STRUCT_DESC: *ABANDONED* Concrete box on both sides found. Pipe remainings are found on WS after the removal of 40 feet of 36" steel pipe from a spur levee and 20 feet of 36" steel pipe from the landside slope of Feather River Levee. Pipe depth 10.0 ft below crown. Application No. 4667, 1964.O&M Manual Sac 144, August 1955, Revision Year 2011. FS Date: 4/12/2013

Crown view- overview of both sides of the levee

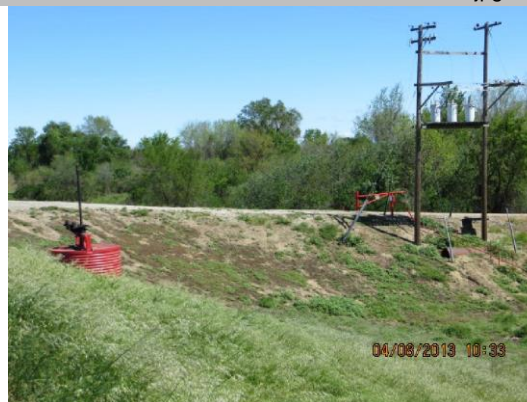
Photo 2 of 3 : UCIP\_SP\_2017\_41624\_18768.jpg

WS- abandoned pipe near power pole (right)

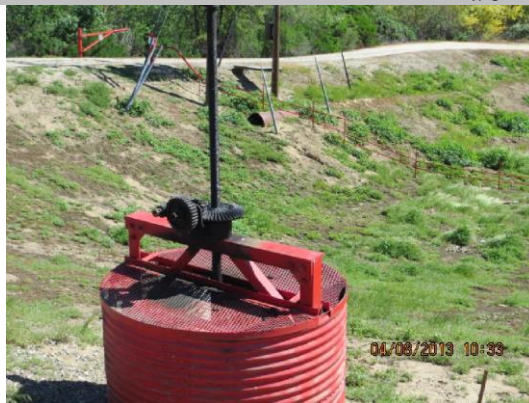
Photo 3 of 3 : UCIP\_SP\_2017\_41624\_18767.jpg

WS- abandoned pipe near power pole (top)

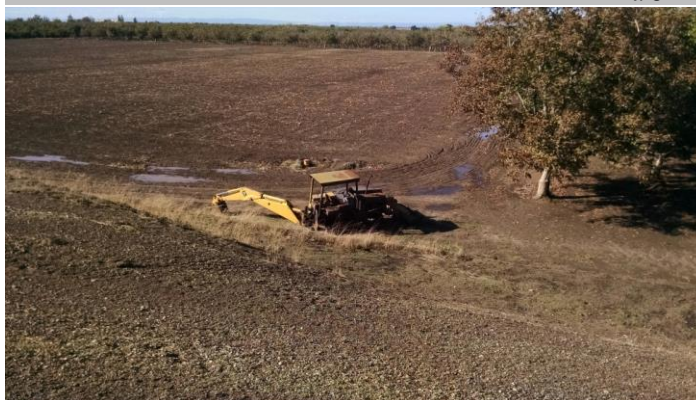
Photo 1 of 2 : SP\_2017\_LD0001S\_433\_13\_20170316\_00001.jpg

LM Start	0.68	Rating **	M	Issue No.	13
LM End	0.68	Issue Type +	En	Location *	LS
Category	Earthen Levee			GPS Latitude/Longitude	
				Start	End
Item	Encroachments			38.960772 °	38.960772 °
				-121.585943 °	-121.585943 °
DWR ID	DWR_LD0001S_01_f_2015_13				
Comment Code					
EQ : Equipment					
Inspector Comment					
Backhoe still at toe of landside levee. Spring 2017.

This picture was from Fall 2015 Inspection but the backhoe is still there and the picture is the same for Spring of 2016. The backhoe was located on the landside toe of the levee.

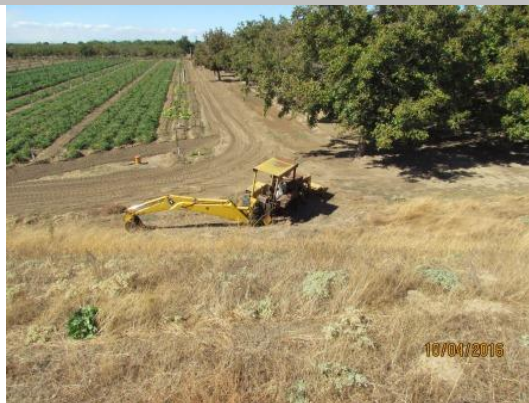
Photo 2 of 2 : SP\_2017\_LD0001S\_433\_13\_20170316\_00002.jpg

Backhoe is still there for Spring of 2017. The backhoe is on the landside toe of the levee.

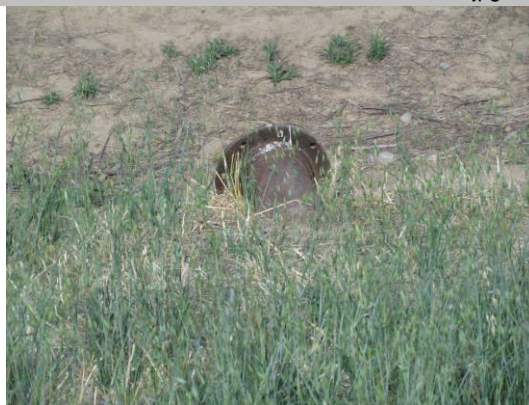
Photo 2 of 3 : UCIP\_SP\_2017\_50641\_75108.jpg

Pipe open on LS end. Photo courtesy of Sterling York, DWR Inspector.

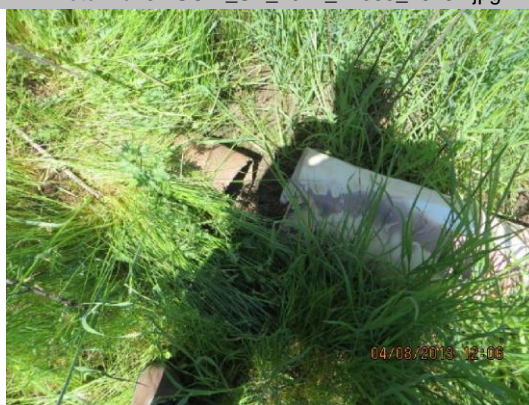
Photo 1 of 3 : UCIP\_SP\_2017\_11383\_18782.jpg

LM Start	2.21	Rating **	M	Issue No.	492
LM End	2.21	Issue Type +	Ma	Location *	LS
Category	Supplemental			GPS Latitude/Longitude	
				Start	End
Item	DWR UCIP LMA Responsibility			38.982135 °	38.982135 °
				-121.591974 °	-121.591974 °
DWR ID					
Comment Code					
Inspector Comment					
FS_ID:11383 DS_ID:17915 EP_NO: N/A Repair Type: Non-Urgent Crossing Status: Found UCIP Comments: Siphon breaker cap missing. Sump pump and gate valve at landward toe not found may be due to dense vegetation. FIELD_STRUCT_DESC: A 8-inch steel drainage pipe through levee, 4.6-feet below the crown. Siphon breaker in corrugated metal riser on landward slope.O&M Manual Sac 144, August 1955, Revision Year 2011. FS Date: 4/12/2013

WS- 8-inch steel pipe and disconnected pvc pipe on levee slope

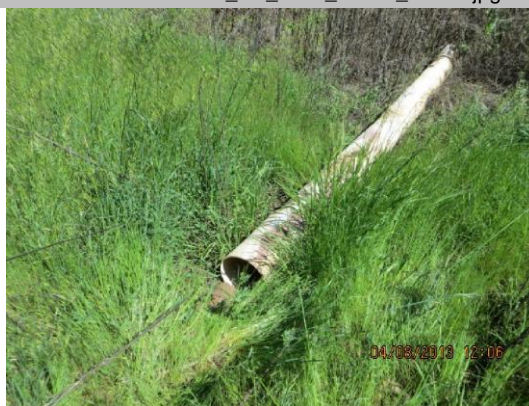
Photo 2 of 3 : UCIP\_SP\_2017\_11383\_18781.jpg

WS-a disconnected pvc pipe on levee slope

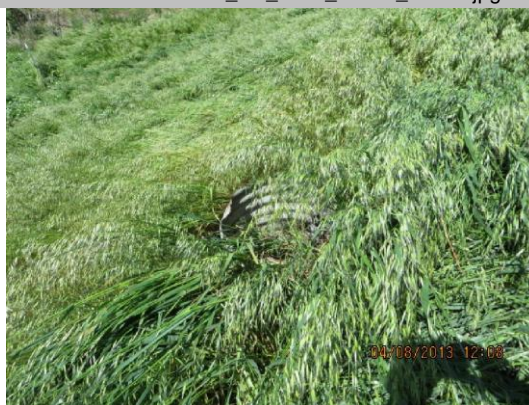
Photo 3 of 3 : UCIP\_SP\_2017\_11383\_18780.jpg

LS- CMP riser on levee slope with dense vegetation.

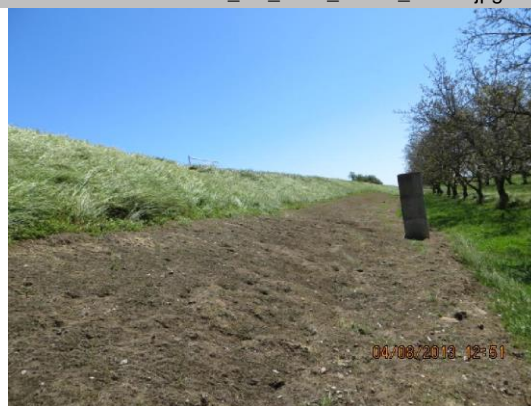
Photo 1 of 3 : UCIP\_SP\_2017\_41787\_18793.jpg

LM Start	2.42	Rating **	M	Issue No.	493
LM End	2.42	Issue Type +	En	Location *	LS
Category	Supplemental			GPS Latitude/Longitude	
				Start	End
Item	DWR UCIP Field Study			38.985223 °	38.985223 °
				-121.591922 °	-121.591922 °
DWR ID					
Comment Code					
Inspector Comment					
FS_ID:41787					
DS_ID:18667					
EP_NO: N/A					
Repair Type: Non-Urgent					
Crossing Status: Found					
UCIP Comments: Pipe appears to be abandoned and should be verified as having been done so properly. - concrete standpipe with 10-inch steel pipe.- concrete wing wall- no pipe- abandoned structure- a pump found on other side of the levee (WS) but not sure whether it is associated with this crossing.					
FIELD_STRUCT_DESC: *ABANDONED* 24" pipe under landside approach and install 10-inch corrugated iron pipe under landside approach(culvert).					
Not found in O&M Manual.					
FS Date: 4/12/2013

LS- overview of landside with concrete standpipe

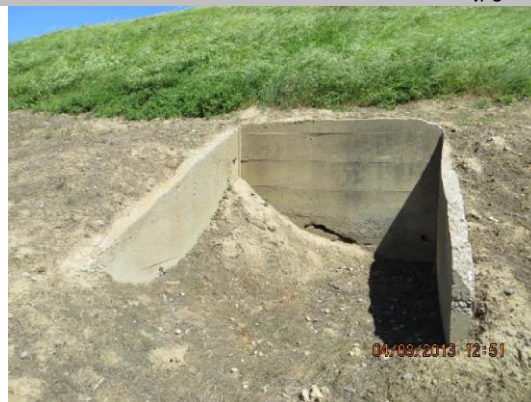
Photo 2 of 3 : UCIP\_SP\_2017\_41787\_18792.jpg

LS- abandoned wing wall- no pipe

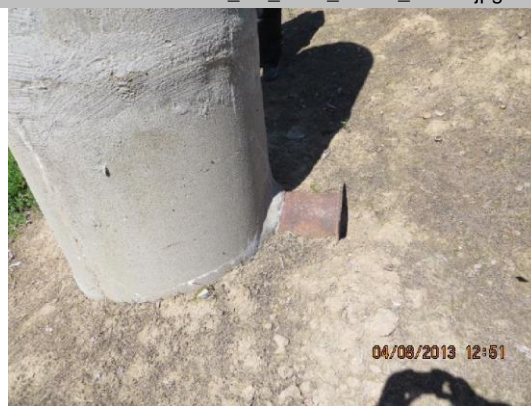
Photo 3 of 3 : UCIP\_SP\_2017\_41787\_18791.jpg

LS- concrete standpipe with disconnected steel pipe

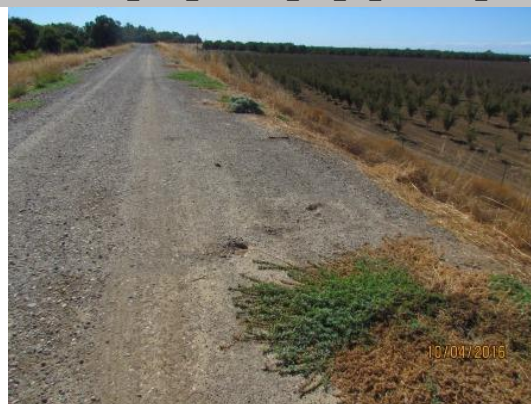
Photo 1 of 2 : SP\_2017\_LD0001S\_433\_17\_20170316\_00005.jpg

LM Start	2.72	Rating **	A/W	Issue No.	17
LM End	2.72	Issue Type +	Ma	Location *	CR
Category	Earthen Levee			GPS Latitude/Longitude	
				Start	End
Item	Animal Control			38.989470 °	38.989470 °
				-121.592502 °	-121.592502 °
DWR ID	DWR_LD0001S_01_s_2015_17				
Comment Code					
A3 : No rodents visible, but rodent burrows visible; need to backfill and compact or grout burrows.					
Inspector Comment					
Animal activity is determined to be goffer not ground squirrel, continue to monitor. Spring 2017.

View of rodent holes on the landside crown and slope. Fall 2016.

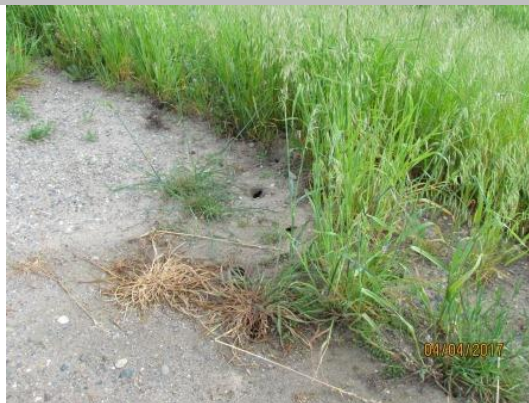
Photo 2 of 2 : SP\_2017\_LD0001S\_433\_17\_20170404\_00066.jpg

Animal activity is determined to be gopher not ground squirrel, continue to monitor. Spring 2017.

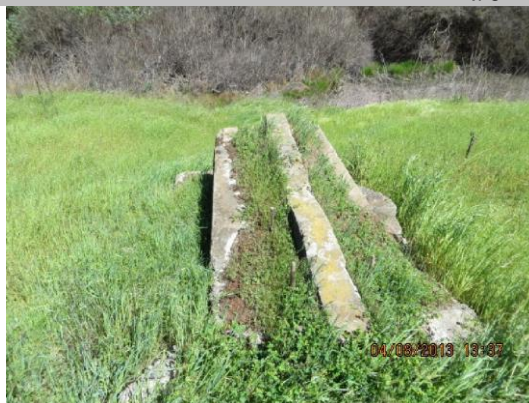
Photo 1 of 3 : UCIP\_SP\_2017\_41348\_18882.jpg

LM Start	3.42	Rating **	M	Issue No.	494
LM End	3.42	Issue Type +	En	Location *	CR
Category	Supplemental			GPS Latitude/Longitude	
				Start	End
Item	DWR UCIP Field Study			38.998858 °	38.998858 °
				-121.596746 °	-121.596746 °
DWR ID					
Comment Code					
Inspector Comment					
FS_ID:41348 DS_ID:17918 EP_NO: N/A Repair Type: Non-Urgent Crossing Status: Indicator Found UCIP Comments: Only an abandoned steel structure on water and a concrete structure on WS Levee slope found. Need to verify pipe was properly abandoned. FIELD_STRUCT_DESC: *ABANDONED* steel 8-inch drainpipe through levee, 4.1 feet below crown. Siphon breaker on landward slope. Butterfly shutoff valve on landward slope, concrete stand pipe and pump at toe of landward slope. Discharges into borrow pit on waterward side. O&M Manual Sac 144, August 1955, Revision Year 2011. FS Date: 4/8/2013

WS- abandoned concrete structure on levee slope

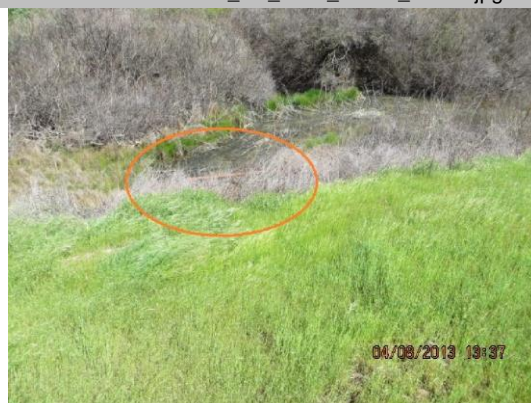
Photo 2 of 3 : UCIP\_SP\_2017\_41348\_18881.jpg

WS- abandoned steel structure on waterway

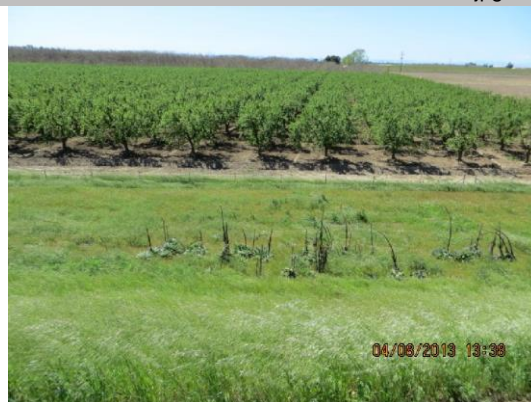
Photo 3 of 3 : UCIP\_SP\_2017\_41348\_18880.jpg

Overview of landside of the levee- no pipes visible. Dense vegetation.

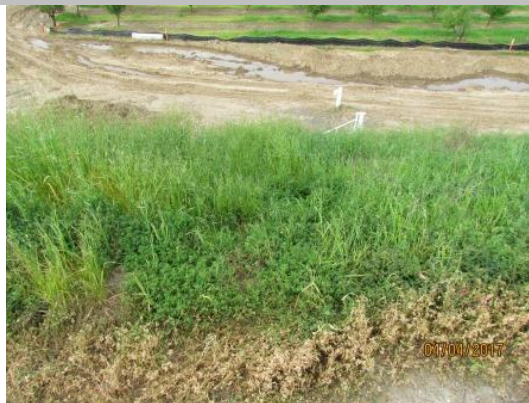
Photo 1 of 2 : SP\_2017\_LD0001S\_433\_21\_20170404\_00065.jpg

LM Start	4.41	Rating **	A/W	Issue No.	21
LM End	4.41	Issue Type +	Ma	Location *	LS
Category	Earthen Levee			GPS Latitude/Longitude	
				Start	End
Item	Slope Stability			39.011493 °	39.011493 °
				-121.603623 °	-121.603623 °
DWR ID	DWR_LD0001S_01_f_2016_21				
Comment Code					
S3 : Repair the levee slope damaged by vehicle traffic and prevent access where possible.					
Inspector Comment					
No erosion or separation on slope, continue to monitor, Spring 2017.

No erosion or separation on the landside slope, continue to monitor, Spring 2017.

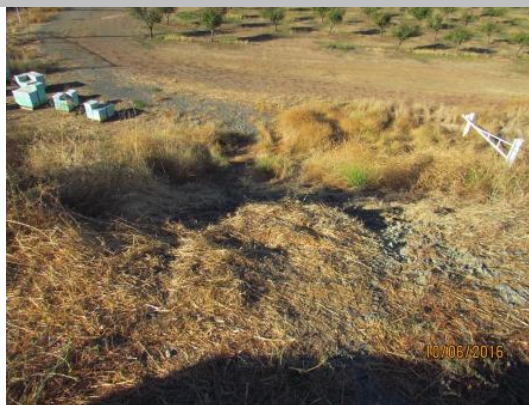
Photo 2 of 2 : SP\_2017\_LD0001S\_433\_21\_20170316\_00008.jpg

View of landside slope where vehicles have been driving up and down to go around gate. Fall 2016.

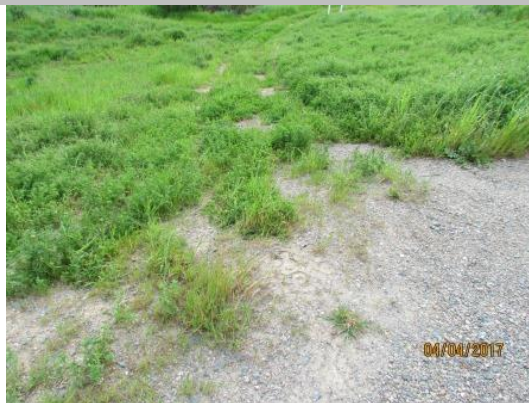
Photo 1 of 2 : SP\_2017\_LD0001S\_433\_36\_20170404\_00067.jpg

LM Start	4.41	Rating **	A/W	Issue No.	36
LM End	4.41	Issue Type +	Ma	Location *	WS
Category	Earthen Levee			GPS Latitude/Longitude	
				Start	End
Item	Slope Stability			39.011493 °	39.011493 °
				-121.603624 °	-121.603624 °
DWR ID	DWR_LD0001S_01_f_2016_36				
Comment Code					
S3 : Repair the levee slope damaged by vehicle traffic and prevent access where possible.					
Inspector Comment					
No erosion or separation on slope, continue to monitor, Spring 2017.

View of waterside slope where vehicles in the past have used to access the crown. No erosion or separation on slope, continue to monitor, Spring 2017.

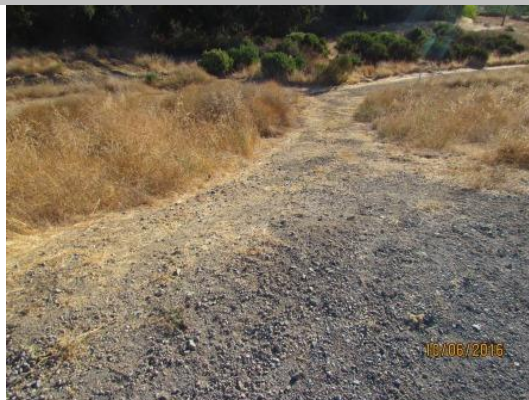
Photo 2 of 2 : SP\_2017\_LD0001S\_433\_36\_20170316\_00018.jpg

View of waterside slope where vehicles have been driving up and down to go around gate. Fall 2016.

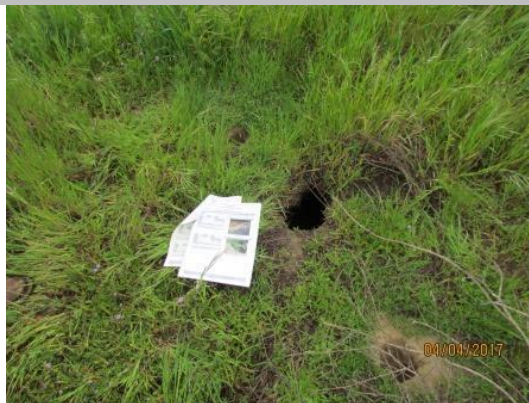
Photo 1 of 3 : SP\_2017\_LD0001S\_433\_20\_20170404\_00068.jpg

LM Start	6.81	Rating **	M	Issue No.	20
LM End	6.81	Issue Type +	Ma	Location *	LS
Category	Earthen Levee			GPS Latitude/Longitude	
				Start	End
Item	Animal Control			39.043262 °	39.043262 °
				-121.611527 °	-121.611527 °
DWR ID	DWR_LD0001S_01_s_2017_20				
Comment Code					
A2 : Repair the levee slope damaged by livestock and prevent large animal access.					
Inspector Comment					
Large animal burrows on slope need to be repaired, Spring 2017.

View of highest point on waterside slope of large animal burrow that needs to be repaired, Spring 2017.

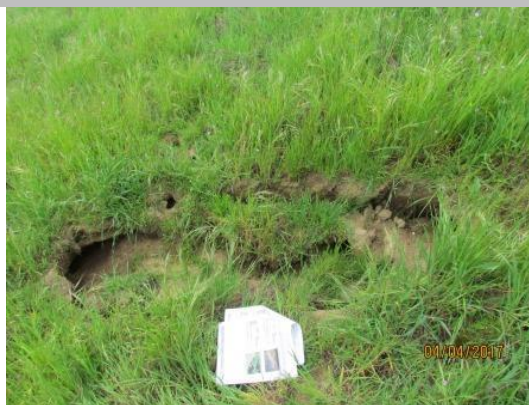
Photo 2 of 3 : SP\_2017\_LD0001S\_433\_20\_20170404\_00070.jpg

View of mid point on waterside slope of the same large animal burrow that needs to be repaired, Spring 2017.

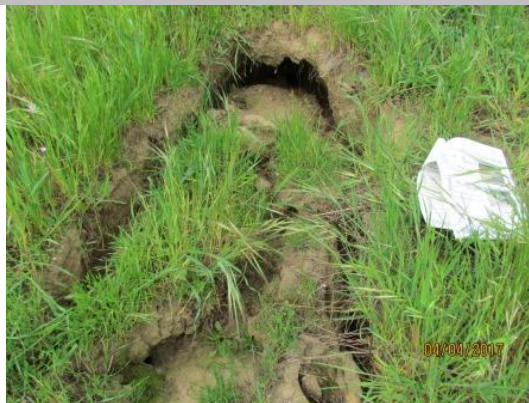
Photo 3 of 3 : SP\_2017\_LD0001S\_433\_20\_20170404\_00071.jpg

View looking up from bottom of waterside slope at the same large animal burrow that needs to be repaired, Spring 2017.

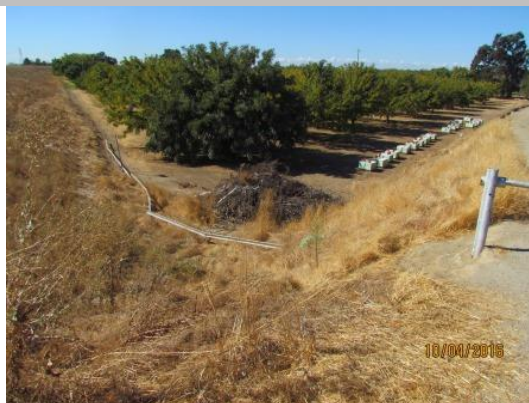
Photo 1 of 1 : SP\_2017\_LD0001S\_433\_23\_20170316\_00009.jpg

View of pruning's on the landside levee toe looking downstream. Fall 2016.

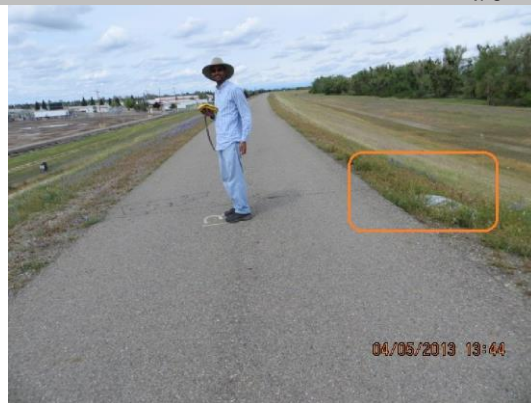
Photo 1 of 3 : UCIP\_SP\_2017\_50675\_19462.jpg

LM Start	11.39	Rating **	M	Issue No.	495
LM End	11.39	Issue Type +	En	Location *	LS
Category	Supplemental			GPS Latitude/Longitude	
				Start	End
Item	DWR UCIP Field Study			39.106261 °	39.106261 °
				-121.607535 °	-121.607535 °
DWR ID					
Comment Code					
Inspector Comment					
FS_ID:50675 DS_ID:18879 EP_NO: N/A Repair Type: Non-Urgent Crossing Status: Not Found UCIP Comments: 07/20/2016 Pipe and pump station removed as part of the Feather River West Levee Project. (K. Fazel - UCIP)04/05/2013 Road pavement cracked along pipe line, needs more investigation. (P. Amatya - DWR) FIELD_STRUCT_DESC: *REMOVED* 2 of 2. A 16-inch pipe (of 6-inch and 16-inch-pipes) through levee, 6.0 feet below crown. Flap gates on waterward end. Siphon breakers in corrugated metal pipe risers on waterward shoulder. Pump house at landward toe. FS Date: 7/20/2016

Levee crown overview- siphon breaker on right

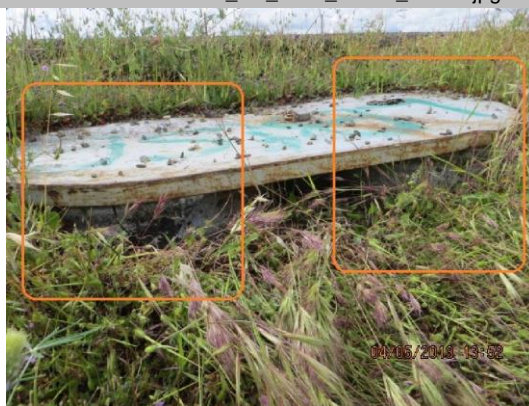
Photo 3 of 3 : UCIP\_SP\_2017\_50675\_19460.jpg

WS- two siphon breaker in CMP riser

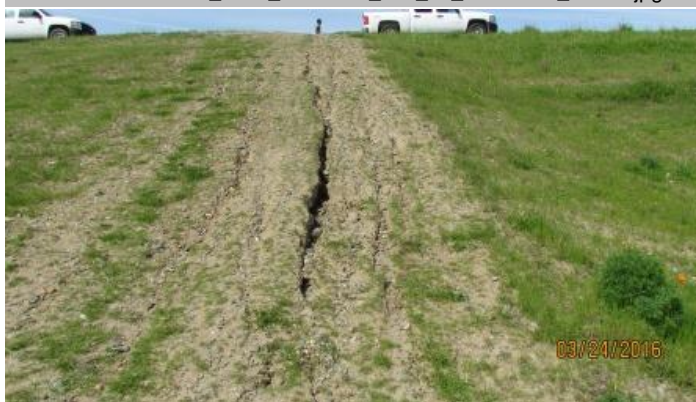
Photo 1 of 2 : SP\_2017\_LD0001S\_433\_42\_20170316\_00023.jpg

LM Start	11.63	Rating **	M	Issue No.	42
LM End	11.63	Issue Type +	Ma	Location *	WS
Category	Earthen Levee			GPS Latitude/Longitude	
				Start	End
Item	Slope Stability			39.109692 °	39.109692 °
				-121.607142 °	-121.607142 °
DWR ID	DWR_LD0001S_01_s_2016_42				
Comment Code					
S1 : Repair slope instability.					
Inspector Comment					
Erosion on the waterside slope caused by rain and foot traffic needs to be monitored. Fall 2016.

Slope erosion due to rain on the waterside. Spring 2016.

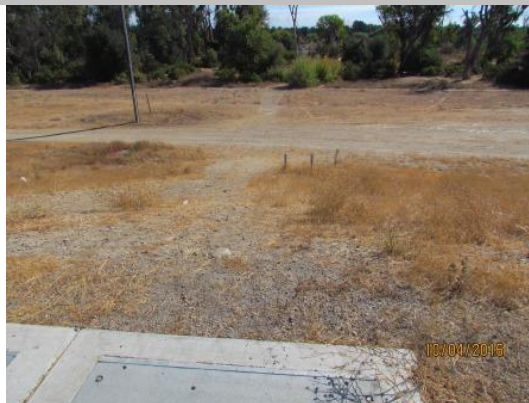
Photo 2 of 2 : SP\_2017\_LD0001S\_433\_42\_20170316\_00024.jpg

View of where slope erosion due has occurred due to rain and foot traffic on the waterside. Fall 2016.

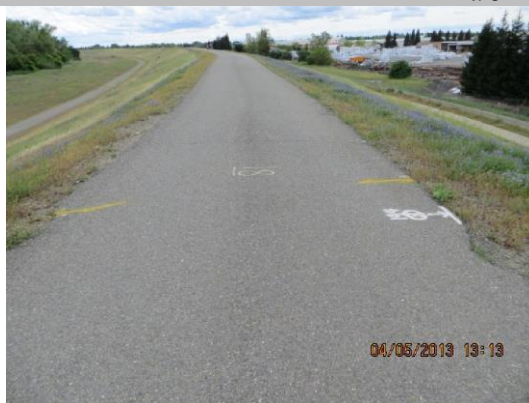
Photo 1 of 3 : UCIP\_SP\_2017\_41841\_19538.jpg

LM Start	11.99	Rating **	M	Issue No.	496
LM End	11.99	Issue Type +	En	Location *	WS
Category	Supplemental			GPS Latitude/Longitude	
				Start	End
Item	DWR UCIP Field Study			39.114856 °	39.114856 °
				-121.605821 °	-121.605821 °
DWR ID					
Comment Code					
Inspector Comment					
FS_ID:41841					
DS_ID:17932					
EP_NO: N/A					
Repair Type: Non-Urgent					
Crossing Status: Indicator Found					
UCIP Comments: Need to install Gasline Markers.Fenced control station.Indicator on LS across concrete ditch.Found road markings.					
FIELD_STRUCT_DESC: 1 of 2. One 16-inch pipe of two 16-inch gas lines through levee, 3 feet below crown. PG&E gas line-crossing sign on waterward shoulder.					
FS Date: 4/5/2013

Levee Crown: gasoline indicator/markings on crown road.

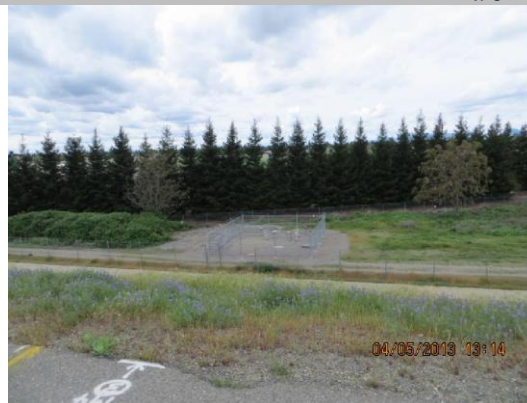
Photo 2 of 3 : UCIP\_SP\_2017\_41841\_19537.jpg

LS- fenced control station across concrete ditch

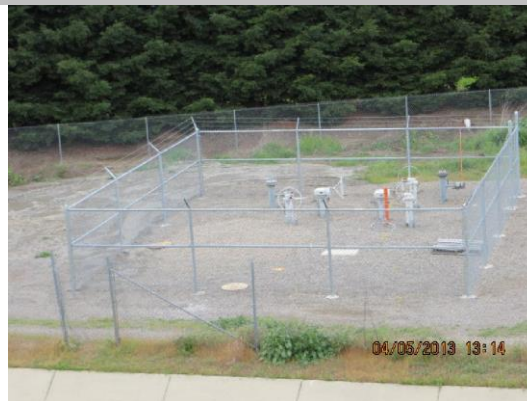
Photo 3 of 3 : UCIP\_SP\_2017\_41841\_19534.jpg

LS- fenced control station with indicators

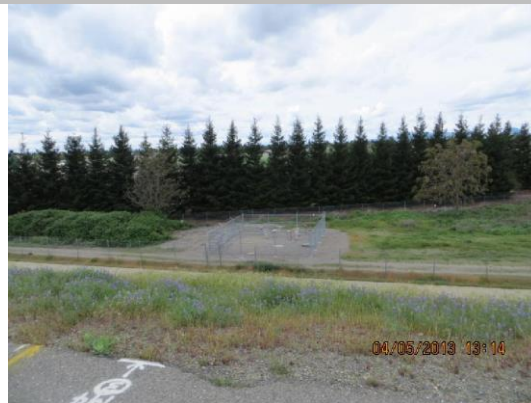
Photo 2 of 3 : UCIP\_SP\_2017\_41889\_19565.jpg

LS- fenced control station across concrete ditch.

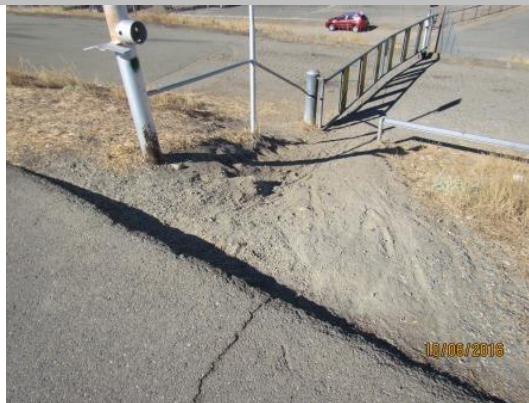
Photo 1 of 1 : SP\_2017\_LD0001S\_433\_40\_20170316\_00021.jpg

View of landside slope at access gate that has been cut into by foot traffic. Fall 2016.

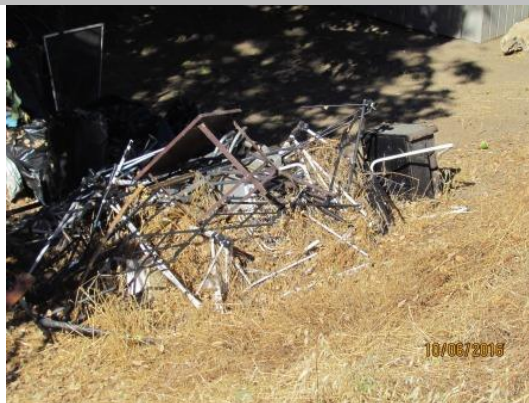
Photo 1 of 1 : SP\_2017\_LD0001S\_433\_41\_20170316\_00022.jpg

View of debris on landside levee slope. Fall 2016.

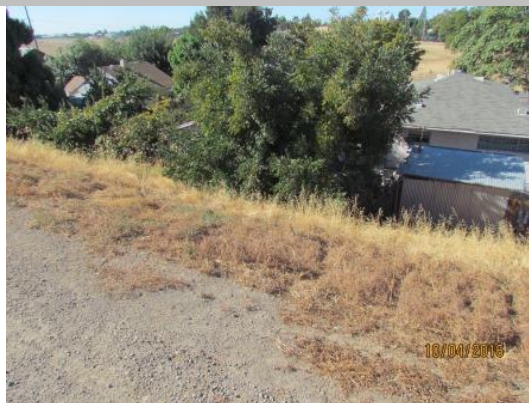
Photo 1 of 1 : SP\_2017\_LD0001S\_433\_27\_20170316\_00012.jpg

Tree at landside levee toe obstructing visibility. Fall 2016.

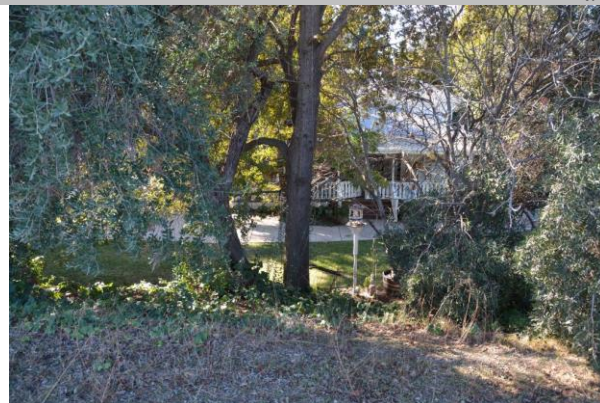
Photo 1 of 2 : SP\_2017\_LD0001S\_433\_18\_20170316\_00006.jpg

Trees and vegetation blocking visibility on the landside slope of the levee. Spring 2016.

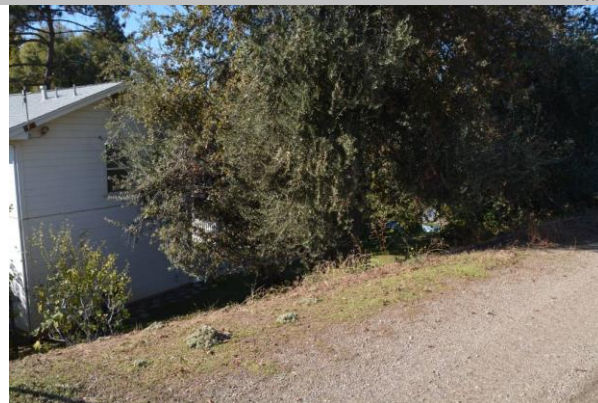
Photo 2 of 2 : SP\_2017\_LD0001S\_433\_18\_20170316\_00007.jpg

Trees and vegetation blocking visibility. Spring 2016.

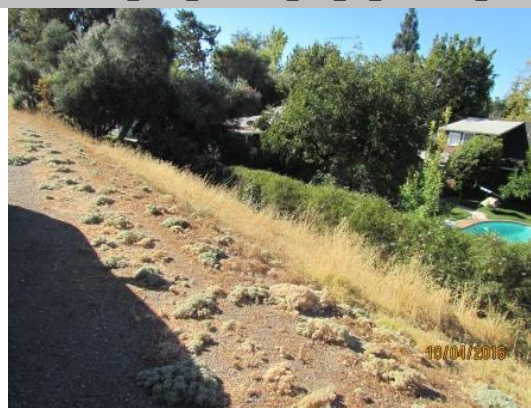
Photo 1 of 1 : SP\_2017\_LD0001S\_433\_38\_20170316\_00020.jpg

View of chain link fence covered with vegetation at landside levee toe. Fall 2016.

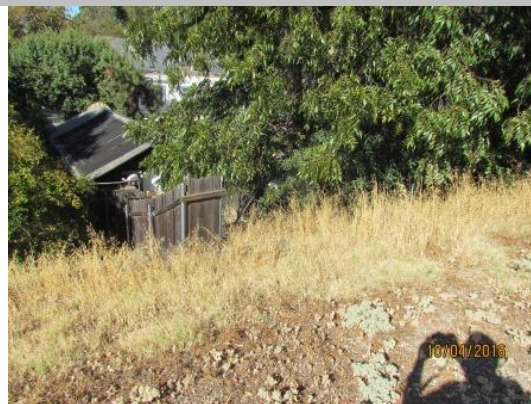
Photo 1 of 1 : SP\_2017\_LD0001S\_433\_37\_20170316\_00019.jpg

View of fence that encroaches half way up the landside levee slope. Fall 2016.

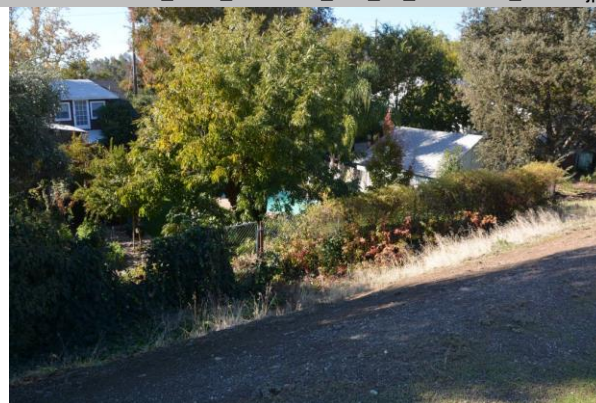
Photo 1 of 2 : SP\_2017\_LD0001S\_433\_24\_20170316\_00010.jpg

Trees and vegetation blocking visibility on the landside toe of the levee.  
Spring 2016.

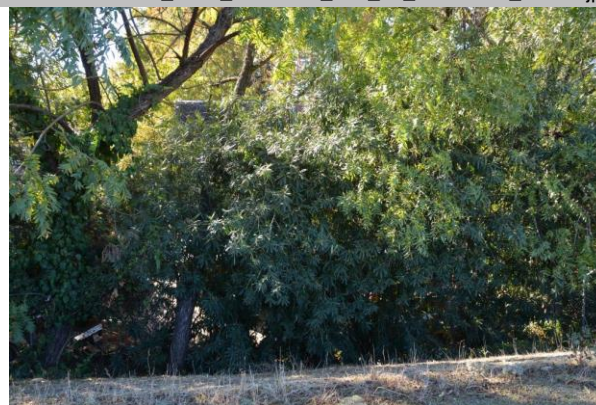
Photo 2 of 2 : SP\_2017\_LD0001S\_433\_24\_20170316\_00011.jpg

Trees and vegetation blocking visibility. Spring 2016.

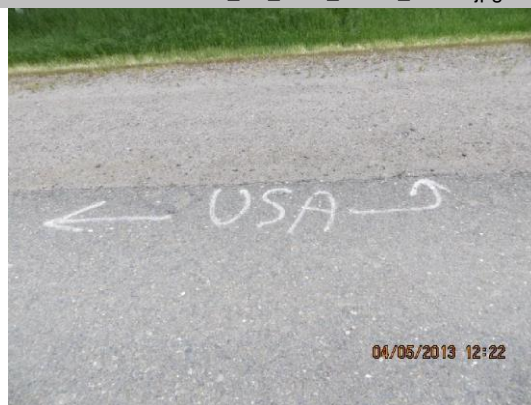
Photo 2 of 3 : UCIP\_SP\_2017\_41887\_19570.jpg

WS- USA road marking on pavement

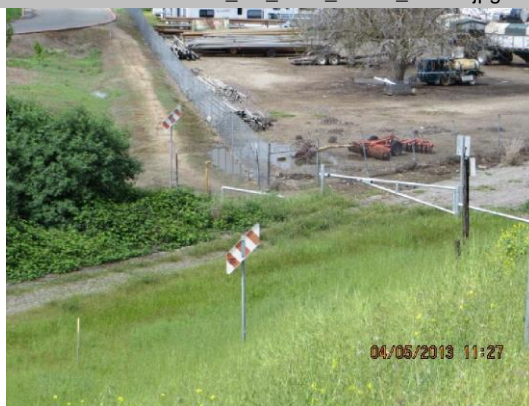
Photo 2 of 3 : UCIP\_SP\_2017\_12104\_19641.jpg

LS- gasline indicators on levee slope and across.

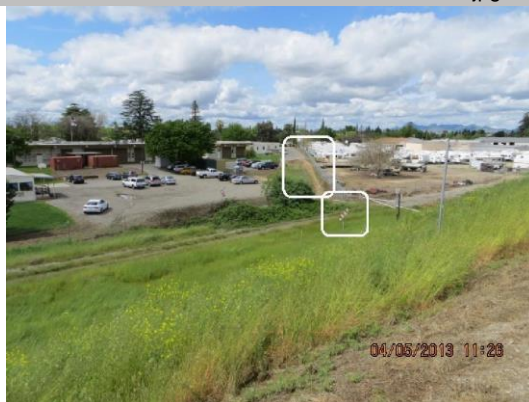
Photo 3 of 3 : UCIP\_SP\_2017\_12104\_19640.jpg

LS- overview of gasline indicators on levee slope and across.

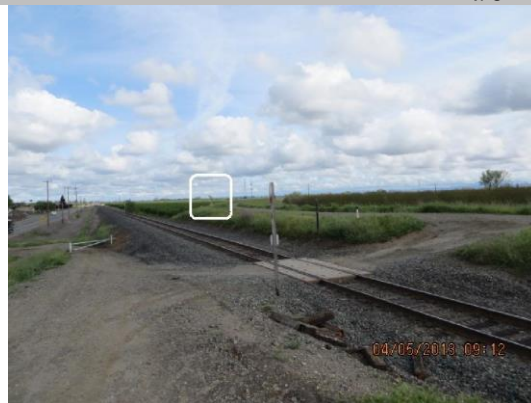
Photo 1 of 2 : UCIP\_SP\_2017\_41888\_19709.jpg

Railway and levee crossing and gasline sign across the railway

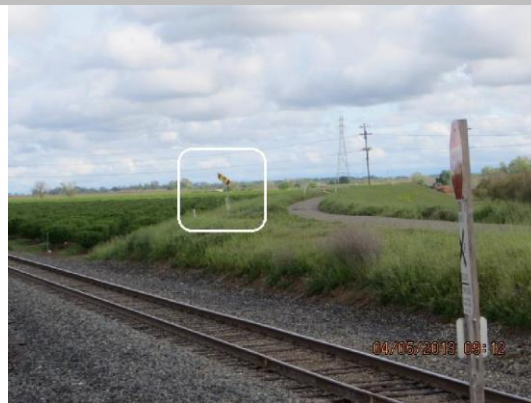
Photo 2 of 2 : UCIP\_SP\_2017\_41888\_19708.jpg

Gasline sign across the railway
